# Baseline Water Quality Monitoring Report: White River Basin at Pike River Road & Taylor Lane, 2009

The mission of the Bad River Watershed Association (BRWA) is to promote a healthy relationship between the people and natural communities of the Bad River watershed by involving all citizens in assessing, maintaining and improving watershed integrity for future generations.

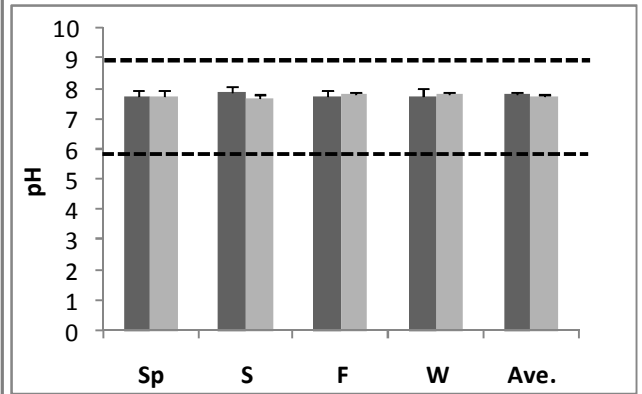
**Results:** pH at both sites was consistently within a healthy 6 to 9 range, indicating good water quality (Graph 1). Continued monitoring will determine if pH at these sites changes more than 0.5 units from the baseline.

Graph 1 (above): Seasonal & overall pH average at Pike River Rd. (dark bars) & Taylor Ln. (light bars) sites. The area in between the dashed lines indicates the State of WI pH standard.

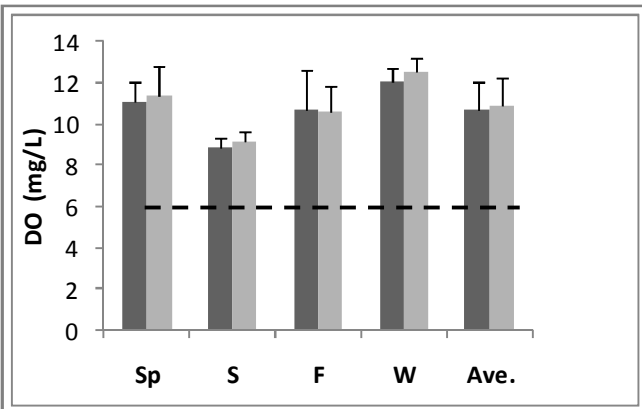
**Results:** Average DO concentrations were above the 6mg/L & 7 mg/L standard (the dashed line) at both sites, which indicates favorable conditions for trout & trout spawning (Graph 2).

Graph 2 (above): Seasonal and overall average DO averages at Pike River Rd. (dark bars) & Taylor Ln. (light bars) sites. The dashed bar indicates the 6mg/L State of WI DO minimum standard for trout streams.

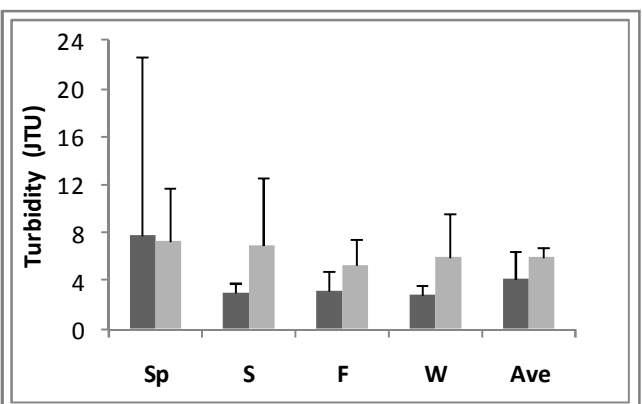
**Results:** Seasonal average turbidity concentration ranged between 3 and 8 JTU (Jackson Turbidity Units, Graph 3). During the spring season at Pike River Rd, the turbidity was generally greater more variable than the other seasons & at Taylor Ln. Undoubtedly a result of sediment contribution during spring run off. This finding warrants additional monitoring.

Graph 3 (above): Seasonal and overall turbidity averages at Pike River Rd. (dark bars) & Taylor Ln. (light bars).

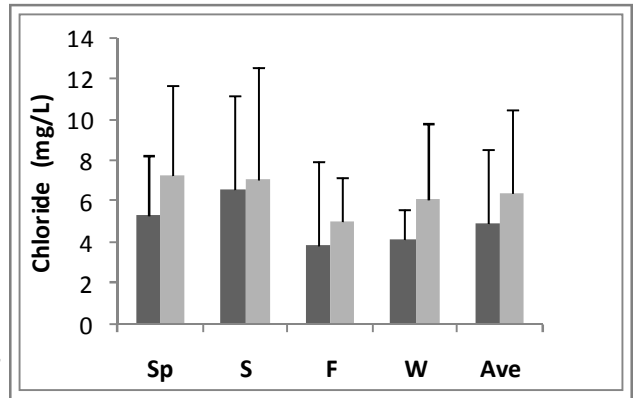
**Results:** Although, seasonal averages ranged between 5 and 7 mg/L, chloride data results were highly variable indicating the need for additional monitoring (Graph 4).

Graph 4: Seasonal and overall chloride averages at Pike River Rd. (dark bars) & Taylor Ln. (light bars).

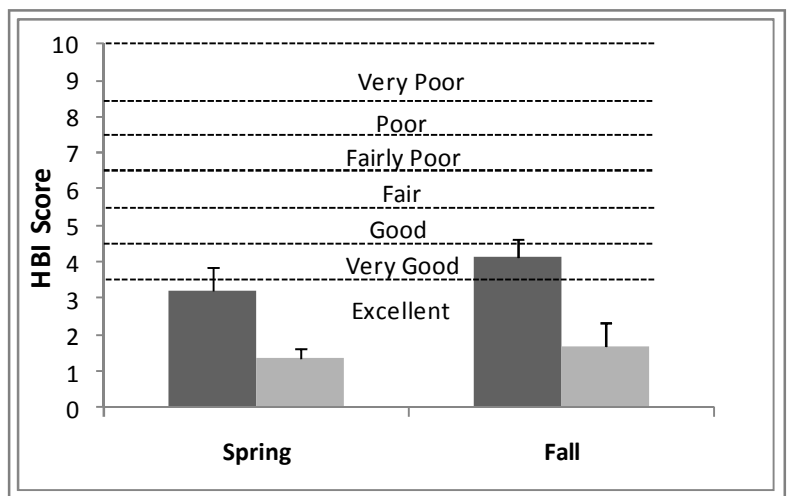
**Results:** The average HBI value for Pike River Rd. is 3.8, indicating “Very Good” water quality. The average HBI for Taylor Ln. is 1.5 , indicating “Excellent” water quality. Values did not differ between seasons (Graph 5).

Graph 5: Average spring & fall HBI values at Pike River Road (dark bars) and Taylor Ln. (light bars).

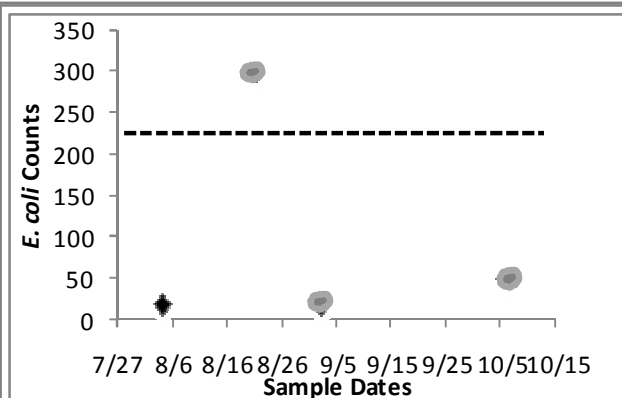
**Results:** At Pike River Rd *E. coli*, data was collected four times, including three during rain events, only in 2007. One of the rain event samples (25% of the total samples) exceeded the EPA standard. Ten samples (two from rain events) were collected over two years at Taylor Ln. One rain event sample (10% of the total samples) exceeded the EPA standard. Wildlife can also contribute to *E. coli* found in rivers, so it is not surprising to find an occasional sample above the EPA standard at these two sites. Continued monitoring will help to determine whether the standard is consistently exceed .

Graph 6: Shows each *e.coli* sampling event at Pike River Rd. One sample exceeded to EPA standard of 235 CFU mg/L (indicated by the dash line). Rain events are indicated by a cloud symbol.

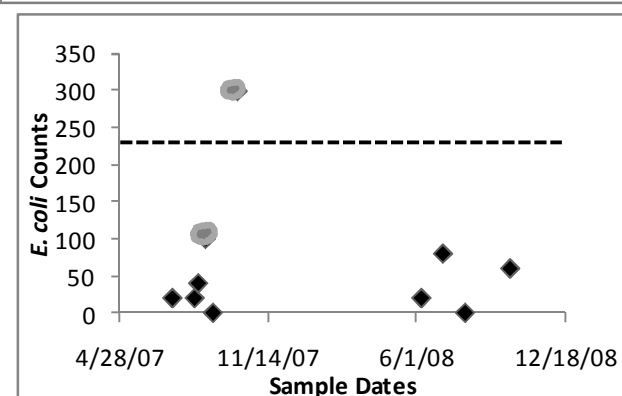
Graph 7: *E.coli* counts for each sampling event at Taylor Ln. One sample exceeded the EPA standard of 235 CFU mg/L (indicated by a dash line). Rain events are indicated by a cloud symbol.
